# **Incident Report**

72 Austin Road, Sudbury, Massachusetts

January 13, 2004

Accident File 04 - 01

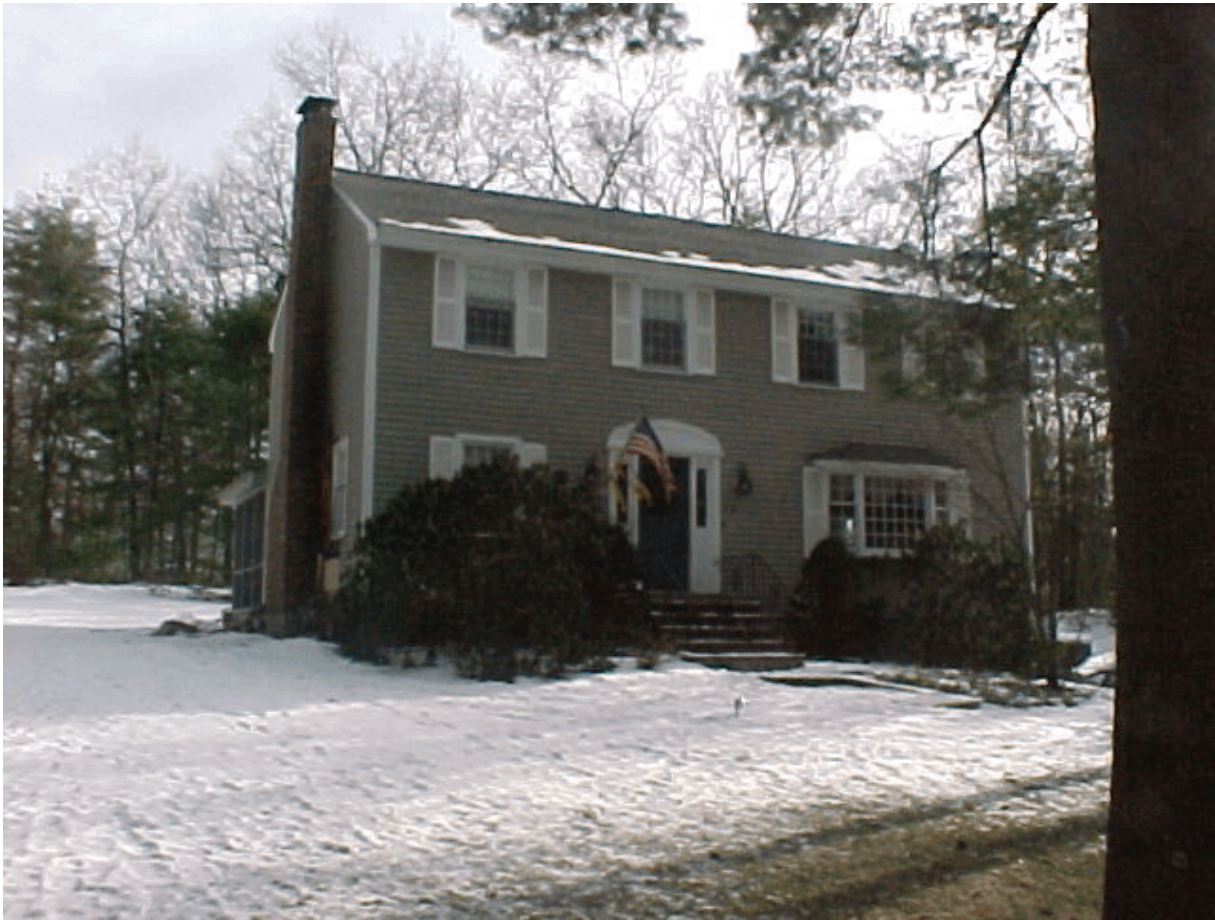
Front view of house.  
Gas meter is located on the left side of the house near the chimney.

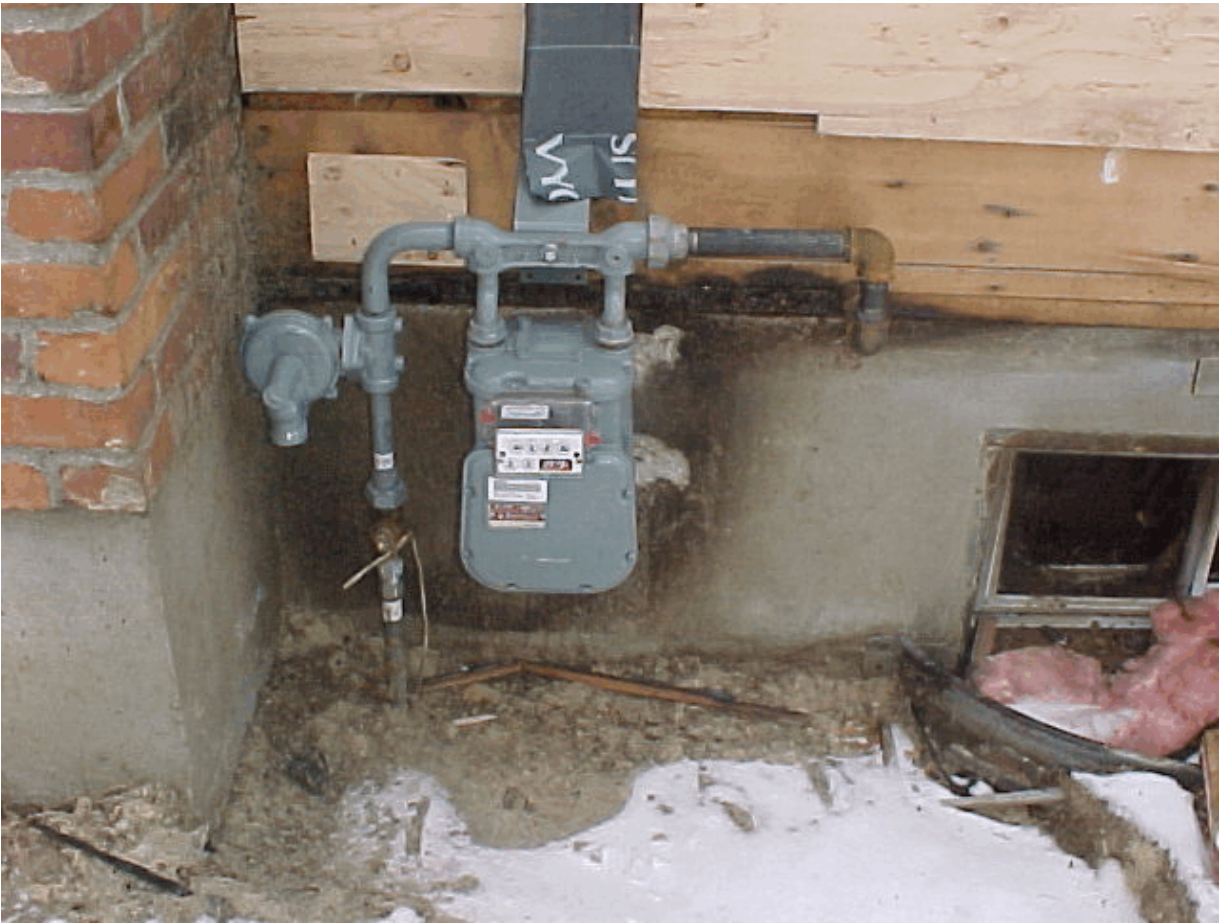
KeySpan removed the meter and service line riser. Upon removal of the natural gas assembly, they noticed that the intake and exhaust vents for one of the furnaces supplying the home were located behind the meter. (id.). The vents were installed after the meter (Exh. 1, 2). KeySpan and the Sudbury Fire Department concluded that the leak from the service riser

was drawn into the intake creating a delayed ignition in the furnace which backfired out of the exhaust and ignited the leaking gas from the service on fire (id.). The vent and heating system had been installed approximately two years prior to the incident (Exh. 2).

Newly installed gas meter and regulator.  
The furnace intake vent pipe has been removed (location of small board).

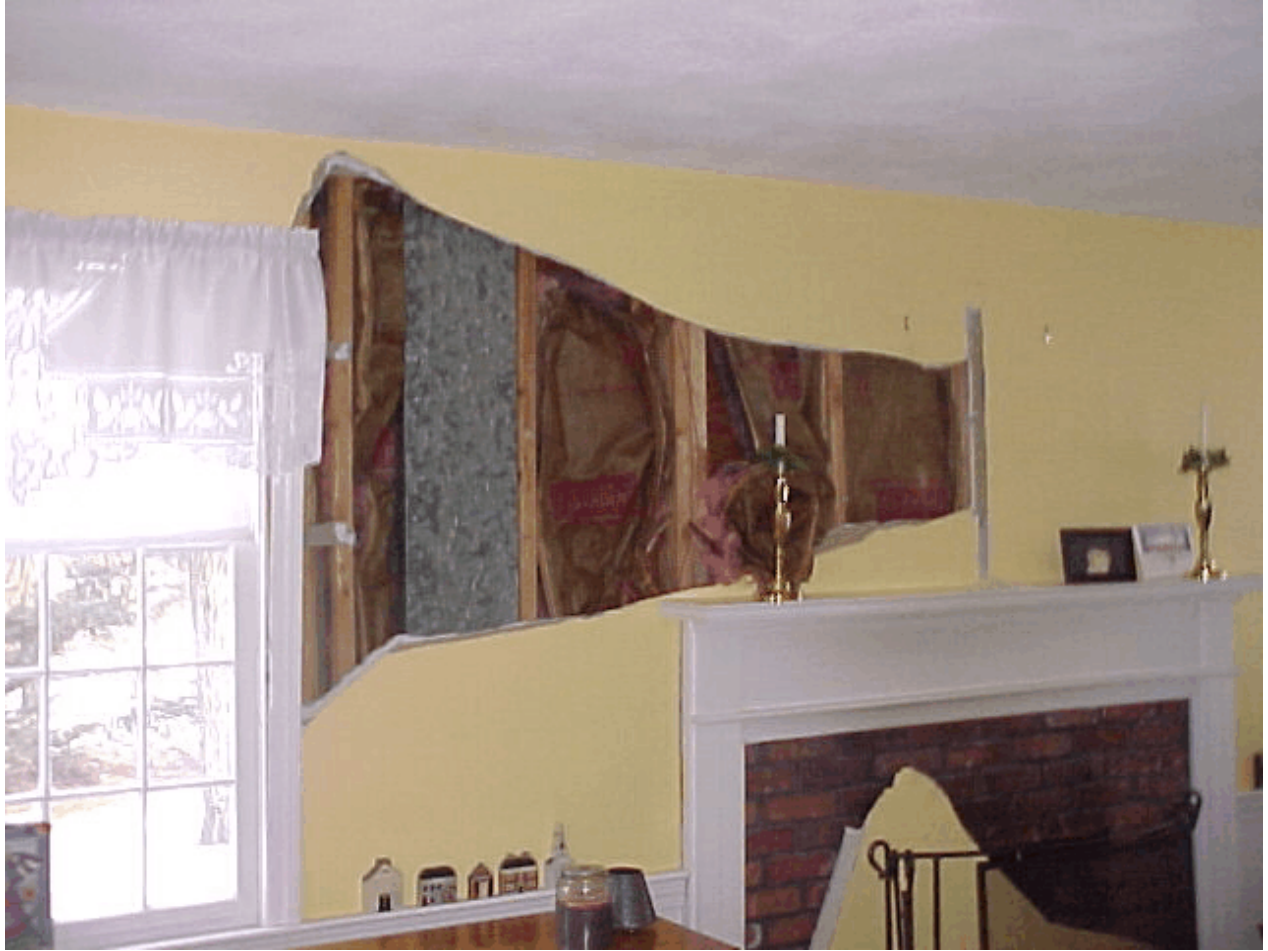
Damage to interior wall of home.  
The gas meter is located outside, directly behind this wall.

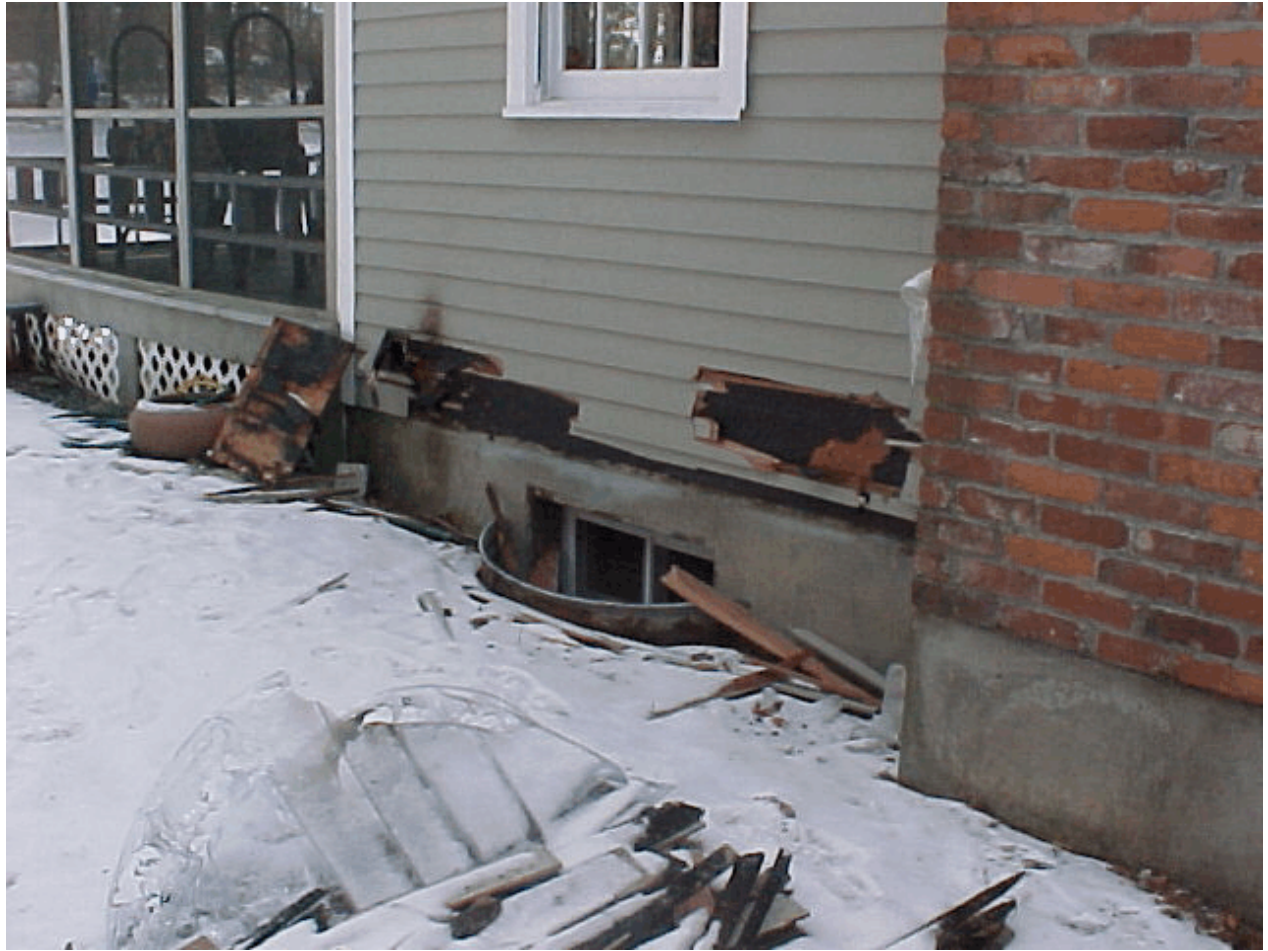
Outside damage to the home (left side of house).

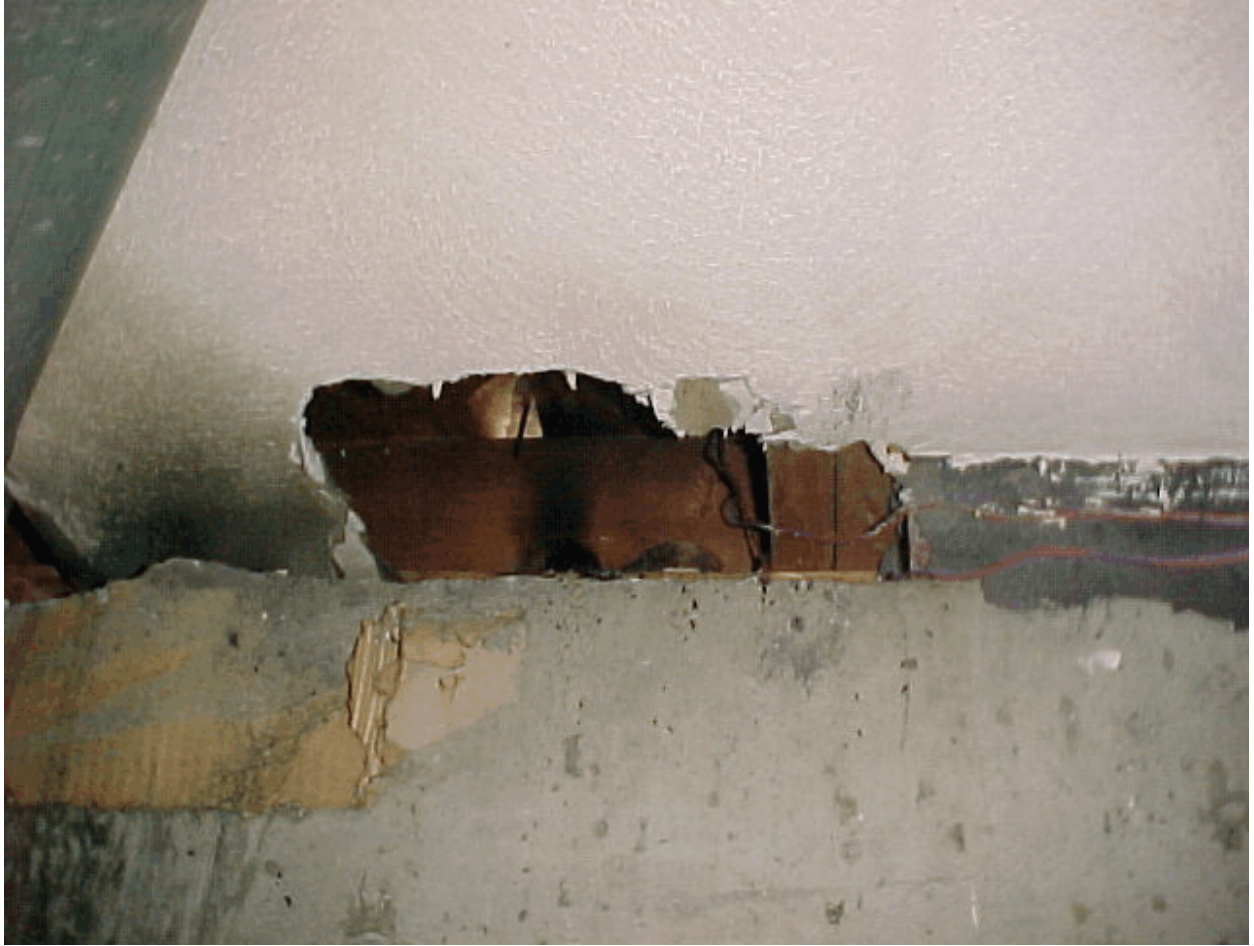
Hole in ceiling in the basement.  
This is in close proximity to the gas meter.

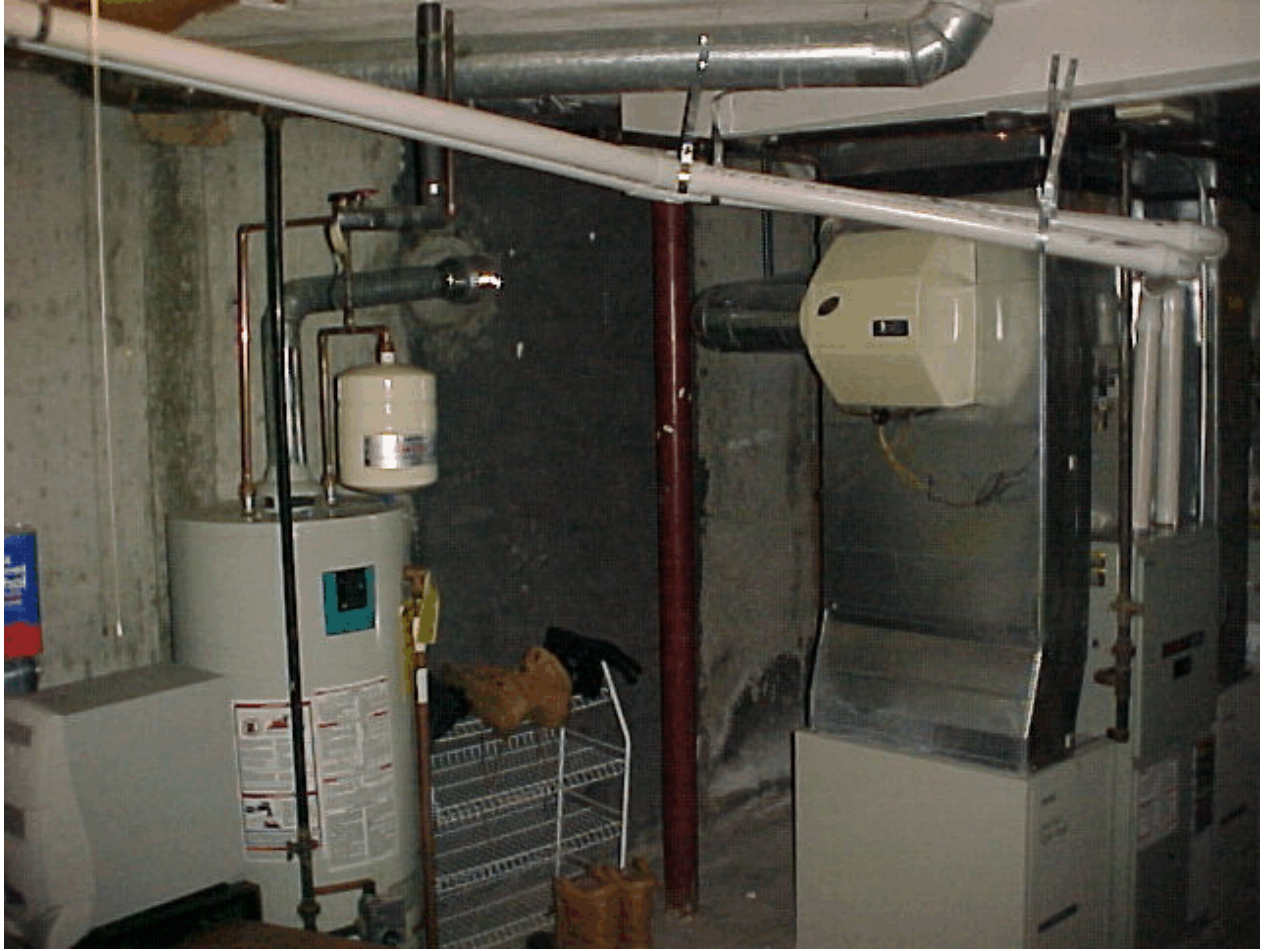
13. The ignition source was a furnace located in the basement. The natural gas entered the basement through vent lines attached to the furnace.
14. KeySpan estimated the property damage to be no more than \$20,000.

Basement area - showing one of the two furnaces.
